Cavitation (damage) strips with span-wise regularity on the guide vanes of Three Gorges turbines (Phenomenon and hypothesis)

Shengcai Li
University of Warwick
S.Li@warwick.ac.uk

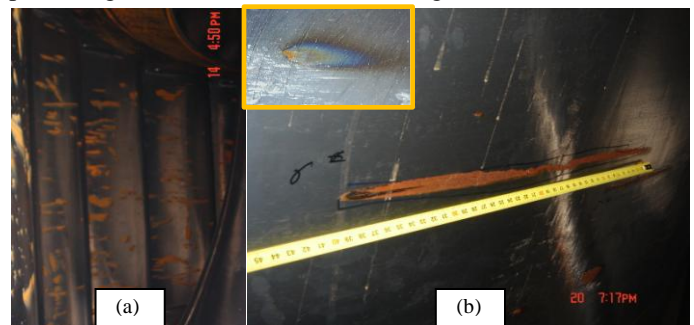
The damage² occurs on the pressure surface (not the suction surface) of the guide vanes (Figure 1) in the form of stream-wise strips³, starting from the zone of favourable pressure gradient (FPG) and extending into the zone of adverse pressure gradient (APG) as shown in Figure 1.

Figure 1. (a) Guide vanes with damage visible on their pressure surface; (b) A representative damage-strip showing the wedged head (inset: a typical heating sign)

These long strips, with almost equal width (approximately 10~20 mm), all have a wedged head as shown in Figure 1(b). They appear with a span-wise regularity of average spacing $\lambda_{\text{strip}} \approx 0.100$ m. The damage depth is much less than 1 mm (touch feel only) and with a corroded rough surface. Signs of heating are also observed. These features are notably different from commonly observed cavitation damage, which usually develops a sponge-like eroded surface. The damaged strips observed on the guide vanes are all such long and narrow shaped and distributed regularly in span-wise. This reminds the author of searching for a delicate flow-structure most likely from the boundary-layer that fits all these features⁴.

The multi-colour zones observed (termed as ‘bluing’ in heat-treatment) indicates a temperature rise to the range of 250°C-600°C. The only possible hydrodynamic mechanism capable of generating temperatures at or above this range is cavitation⁵. Single bubble luminescence [8, 9 and 10] has proven a heat source in the order of $10^3 K$ and so to be expected from the work on hydrodynamic (bubble) cloud luminescence [11].

The material used for the Three Gorges turbines is X3CrNiMo13-4 (EN-1088), which is close or equivalent to martensitic stainless steel CA6MN (12.9% Cr, 4% Ni and 0.04% C), commonly used for turbine fabrication [12]. The corrosive appearance of the damage in particular its very shallow depth (touch feeling only) readily tempts one to conclude corrosion being responsible for the damage. The analysis in the full paper will show corrosion is merely a consequence of cavitation attacks through a process of *Sensitisation* that is a phenomenon relating to heat induced inter-granular corrosion [13].

All available evidence convincingly suggests a hypothesis for this type of cavitation (erosion). Its inception is likely triggered by the breakdown of the boundary layer K-mode streaks. The resultant damage patterns reflect well the features of the turbulent production from the breakdown of these streaks. The corrosion is not the cause but a consequence.

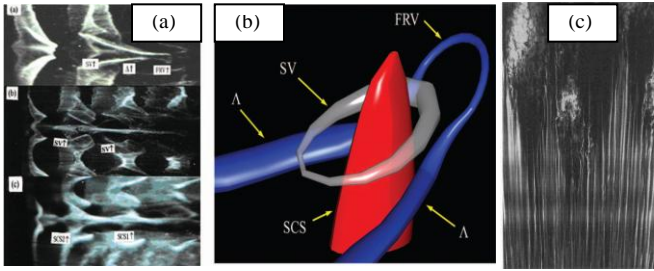
Figure 2 Streak structure & breakdown: (a) photos of typical hydrogen-bubbles in laminar streak formation illuminated by a laser sheet at different horizontal heights. SCS, the secondary closed vortex; SV the secondary closed vortex and FRV the first ring vortex [20]; (b) 3-D structure reconstructed from these detailed photos [20]; and (c) Streak observed through smoke visualization in a laminar boundary layer subject to 2.2 % free-stream turbulence [23]

there must be a flow structure in the boundary-layer capable of creating such negative pressure drops lasting long enough time for nuclei to cavitate [15]. The breakdown of K-mode streaks [16] and associated turbulence production is just such an ideal flow environment if the free-stream pressure *there* is also sufficiently low (but not necessarily down to the vapour pressure). Such a flow structure is shown, e.g. by Figure 2.

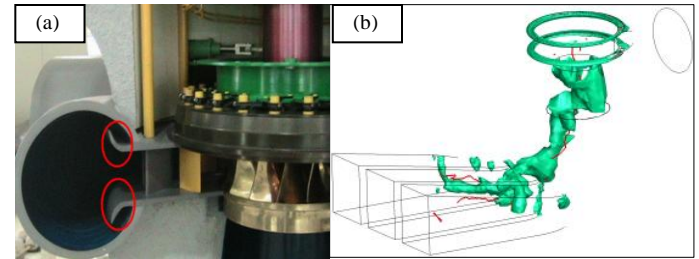
Figure 3 (a) Wrongly designed guide-plate (circled) on 3-Gorges (left power plant) turbines [6]; (b) This guide-plate inducing a huge vortex structure occupying whole flow passage. It is responsible for a gust-like dominating turbulence of extremely low frequency (0.336 Hz) in free-stream that has the highest receptivity to boundary-layer, promoting K-mode instability [6]. Referring to [24 and 25] for background information.

For extremely large turbines with high prototype-model ratio (such as 28 for the Three Gorge turbines), these two scale effects are all extremely manifested, presenting a real challenge for giant hydro schemes, referring to Figure 3.
